**Flood Control Project Maintenance
Levee Inspections**

Maintenance Issue Types Only, Levee Inspection Report By Mile - Fall 2014

Reclamation District No. 0551 Pearson

Waterway	Bank	Unit Miles	Inspection Start/End	Inspector
Unit No. 01 Sacramento River	Left	6.78	11/07/2014 11/07/2014	Herman Phillips

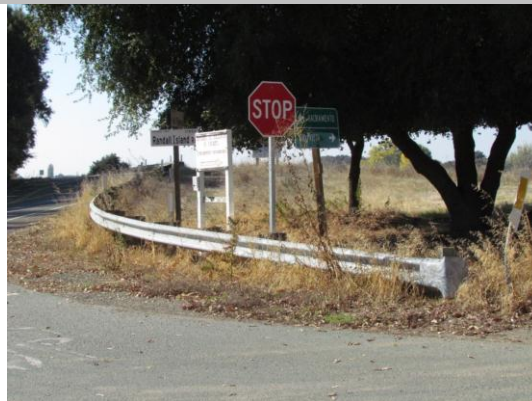
Photo 1 of 1 : FA_2014_RD0551_175_26_20141113_00017.jpg

LM Start	0.00	Rating **	M	Issue No.	26
LM End	6.78	Issue Type +	Ma	Location *	WS
Category	Earthen Levee			GPS Latitude/Longitude	
				Start	End
Item	Vegetation			38.336458 °	38.258904 °
				-121.564751 °	-121.517904 °
DWR ID	DWR_RD0551_01_f_2014_26				
Action/Comments					
Control annual grass and weeds on the levee slopes and easements.

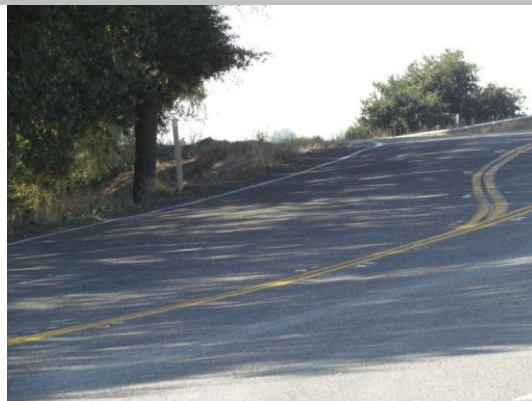
Photo 1 of 1 : FA_2014_RD0551_175_25_20141107_00016.jpg

LM Start	0.00	Rating **	A	Issue No.	25
LM End	6.84	Issue Type +	Ma	Location *	LS
Category	Earthen Levee			GPS Latitude/Longitude	
				Start	End
Item	Vegetation			38.336458 °	38.258904 °
				-121.564751 °	-121.517904 °
DWR ID	DWR_RD0551_01_f_2014_25				
Action/Comments					
Control annual grass and weeds on the levee slopes and easements. Inspector Comments: The District has the goats go through and remove the vegetation from the levee slope, from 0.00 to 6.78. Good job.

Looking downstream from levee mile 0.00 landside slope.
